INDOOR AIR QUALITY POST-OCCUPANCY ASSESSMENT

**Executive Office of Health and Human Services
Service Center
49 Nursery Lane
Fitchburg, MA**

Prepared by:
Massachusetts Department of Public Health
Bureau of Environmental Health
Indoor Air Quality Program
November 2018

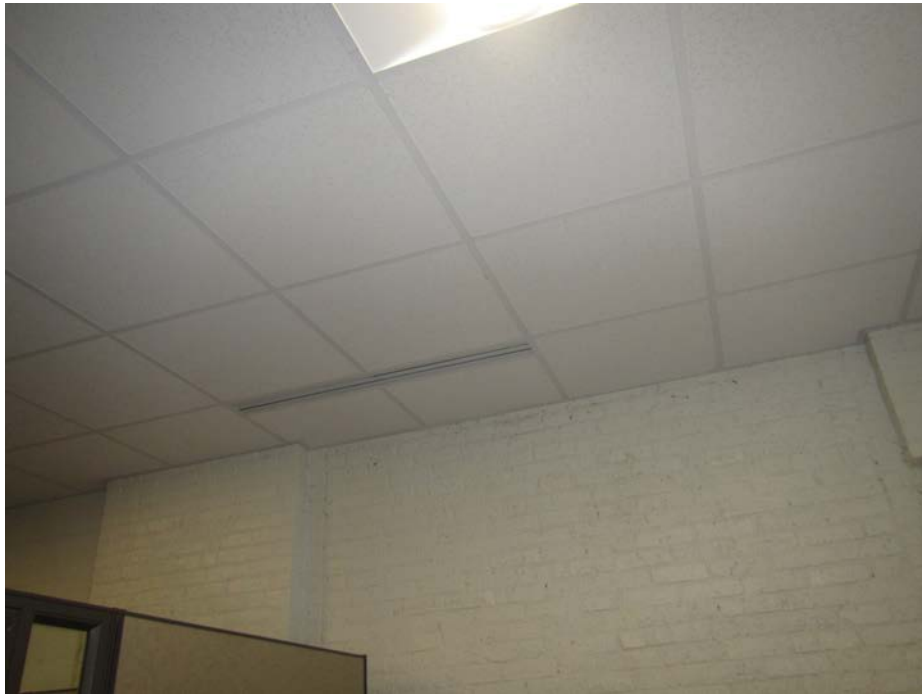
Picture 1

Fresh air is provided by air-handling units (AHUs) located on the roof. Operation of the building's HVAC system is controlled by an automated computer system. Air from the AHUs is filtered, heated/cooled, and delivered to rooms via ducted supply vents (Picture 1). Air is returned/exhausted through return vents. It is recommended that HVAC systems be re-balanced every five years to ensure adequate air systems function (SMACNA, 1994). It was reported that the system was balanced prior to occupancy. It was reported that exhaust vents in the restrooms and kitchen areas vent directly outside. Direct-vented exhaust is recommended in areas where moisture and odors may be generated.

One style of supply vent in the office

15. Clean carpeting in accordance with IICRC recommendations (IICRC, 2012).
16. Clean supply and exhaust vents, personal fans, and heaters regularly to prevent aerosolization of debris.

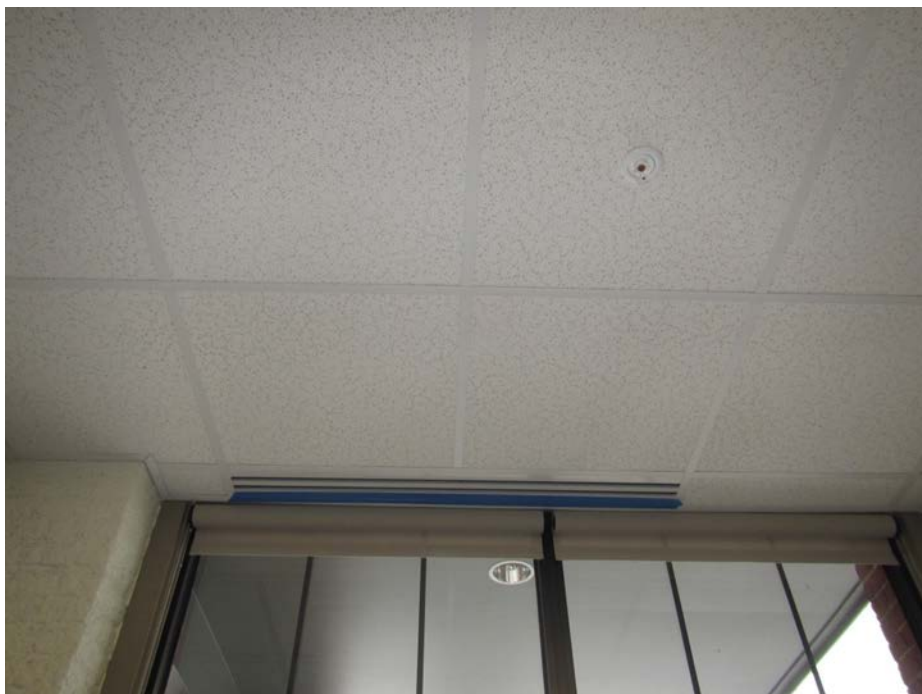
Picture 2

In a few offices, there was tape over the supply vents (Picture 2). Vents should remain unobstructed for proper airflow once the system has been balanced. If this tape is in response to

concerns about drafts, building maintenance staff should be contacted for adjustments of the system. Also note that offices with windows were frequently noticeably cooler than those in the interior during the assessment. Few, if any, thermostats for were found in exterior offices, so the system may not properly account for temperature differences between interior and exterior offices. If occupants express concerns about temperature in the exterior offices, additional thermostats should be located there and the computer system adjusted to supply more heat to those offices.

Tape on supply vent

1. Operate supply and return ventilation continuously (“fan on”) during occupied periods.
2. Remove tape from vents.
3. Have the HVAC system balanced every 5 years in accordance with SMACNA recommendations (SMACNA, 1994).

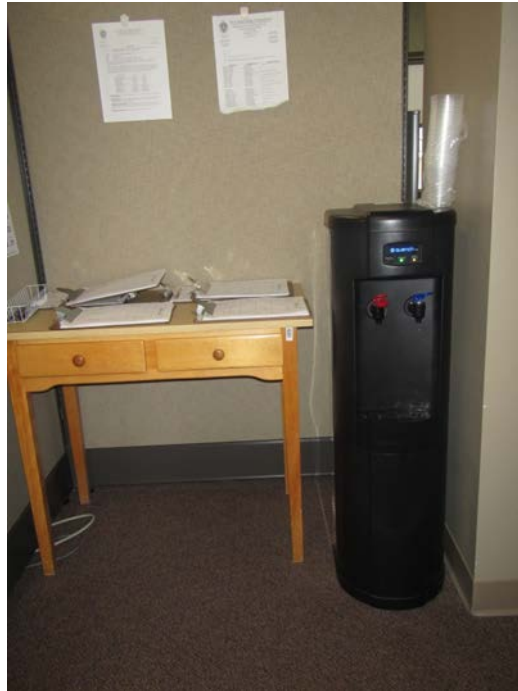
Picture 3

Several water coolers were located in carpeted areas (Picture 3). Spills or leaks from these appliances can moisten the carpet, leading to odors and microbial growth.

Water cooler on carpet

6. Monitor any areas where building envelope leaks have occurred and ensure there is a system for prompt reporting.
7. Place refrigerators and water dispensing equipment in areas without carpeting or use a waterproof mat underneath them.

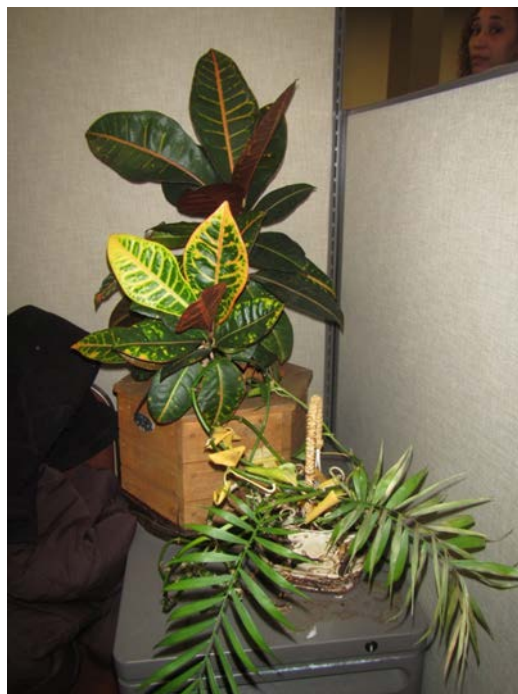
Picture 4

Plants were present in some areas (Picture 4; Table 1). Plants can be a source of pollen and mold, which can be respiratory irritants to some individuals. Plants should be properly maintained and equipped with drip pans to prevent water damage to porous materials. Plants should also be located away from air diffusers to prevent the aerosolization of dirt, pollen, and mold.

Plants in the office

8. Keep plants in good condition, avoid overwatering, and avoid placing them on porous items such as carpets or paper.
9. Ensure all doors between occupied and unconditioned spaces are sealed with weather-stripping and kept closed.

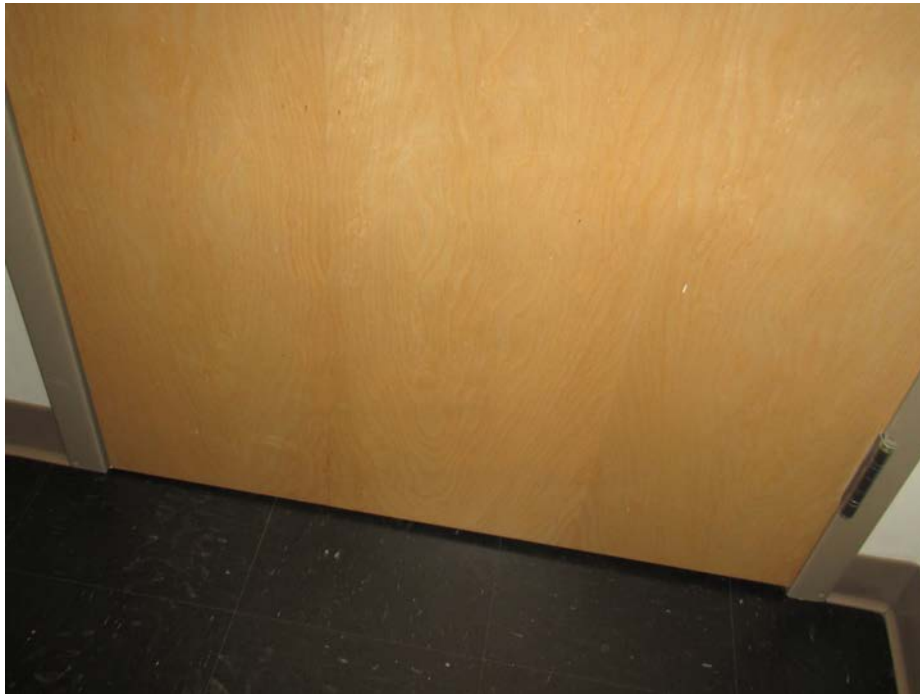
Picture 5

The building has a crawlspace access door in the stairwell that lacked weather-stripping (Picture 5), which can allow odors and pests to migrate into occupied areas. Other doors between occupied and unconditioned spaces, including outdoors, should be rendered tight using weather-stripping, and kept closed.

Space under door to crawlspace from stairwell

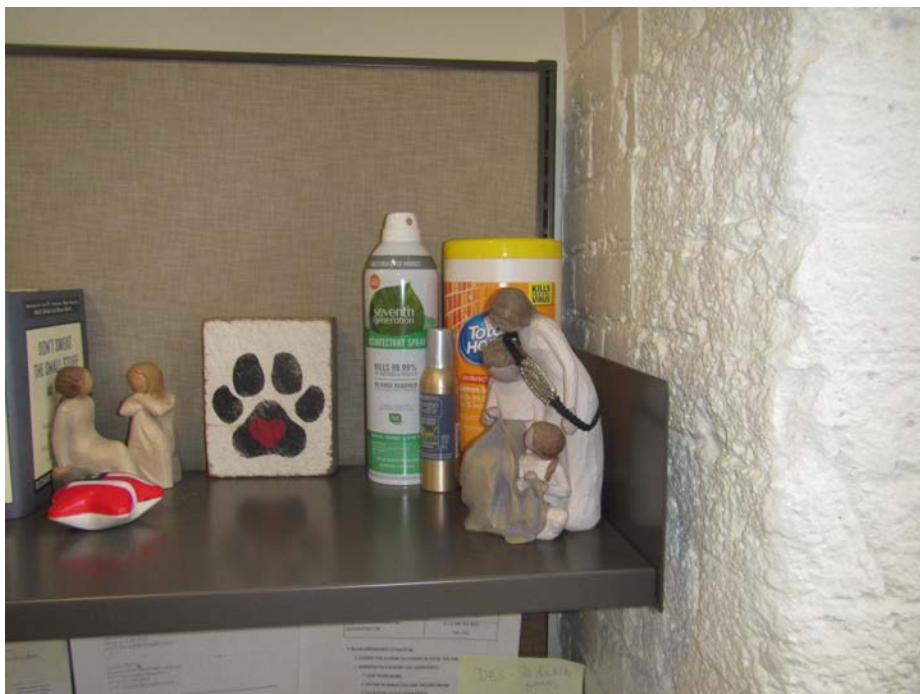
Picture 6

Exposure to low levels of total volatile organic compounds (TVOCs) may produce eye, nose, throat, and/or respiratory irritation in some sensitive individuals. To determine if VOCs were present, BEH/IAQ staff examined rooms for products containing VOCs. BEH/IAQ staff noted dry erase markers, cleaning products, air freshening products and hand sanitizers in use

within the building (Pictures 6 and 7; Table 1). All of these products have the potential to be irritants to the eyes, nose, throat, and respiratory system of sensitive individuals. The scented items in one office may be responsible for the elevated level of PM2.5 found there (Table 1).

Cleaning products

10. Reduce use of cleaning products, sanitizers, and scented products.
11. Ventilate storerooms to reduce lacquer odors from shelving; wash shelving if needed.

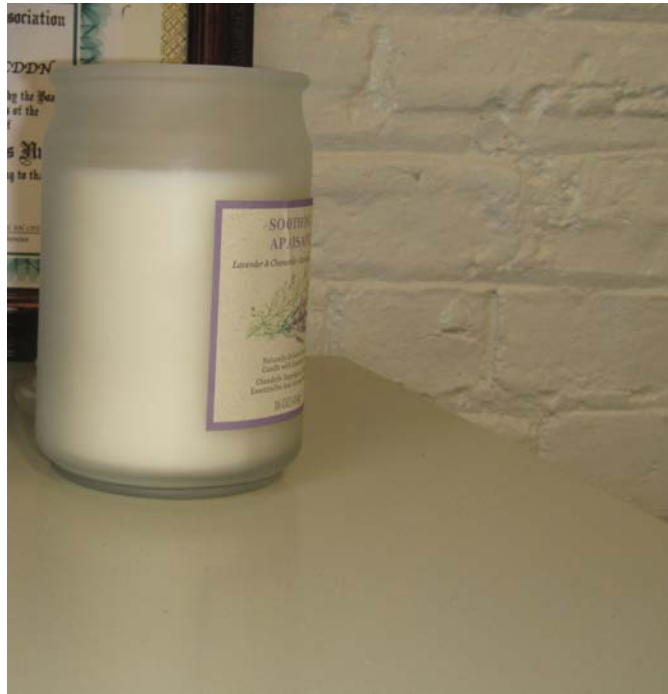
Picture 7

Scented candle

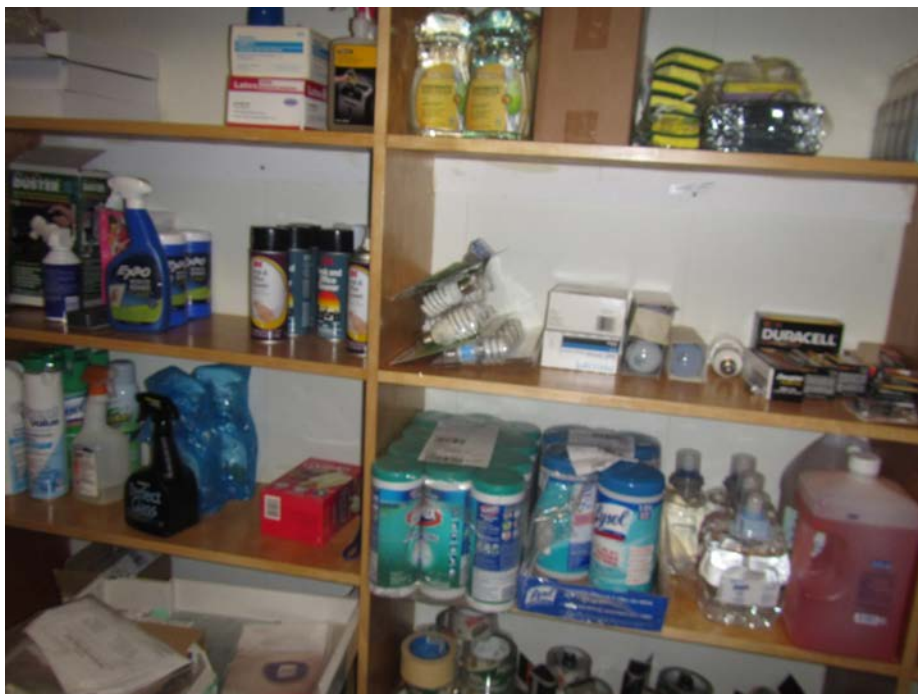
Picture 8

Several storage areas had slight odors. In two of these rooms, wooden built-in shelves (Picture 8) had been sealed with a lacquer material that seemed to be the source of the odor. This odor should dissipate as the material finishes off-gassing, but this can be sped up by increasing ventilation when possible. If odors persist, it may help to wash the shelving with a mild detergent and allow to dry fully. Odors in another storage room seemed to be from some of the stored materials. Boxes containing printed materials or plastic items should be kept closed when not in use to minimize off-gassing.

Built-in shelving with lacquer odor and items which can also be sources of odors

12. Ensure boxes of printed and plastic-containing materials are kept closed when not in use.
13. Keep food in tightly sealed containers and keep kitchen equipment clean.

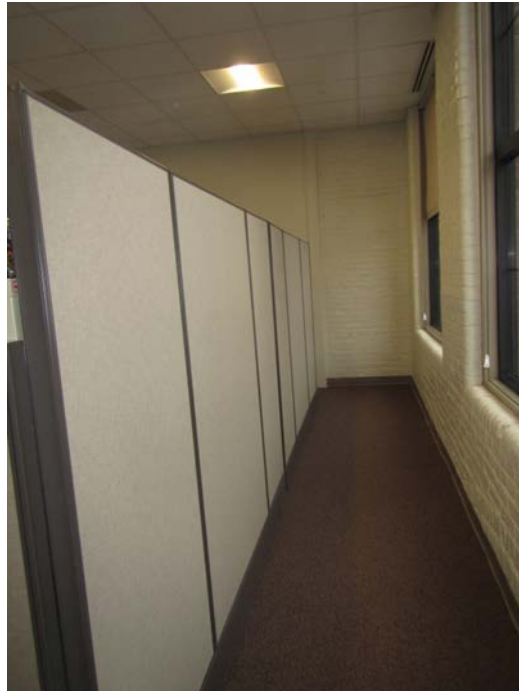
In a few areas, boxes and other items were stored on the floor. Also note that the arrangement of cubicles in one section of the office creates an aisle next to the windows (Picture 9). Areas like this tend to attract clutter and may not be effectively cleaned, which creates harborage for pests. In general, excessive stored materials and accumulated items make it more difficult for custodial staff to clean (Table 1). Items should be stored neatly and moved periodically to allow for wet-wiping and vacuuming of surfaces.

Aisle between cubicle walls and windows

14. Store items in an organized manner and off the floor. Move items periodically to allow for cleaning, including vacuuming and wet wiping of surfaces to remove dust. Ensure that areas like that shown in Picture 9 are a regular part of the cleaning program.
